POLISH-EGYPTIAN ARCHAEOLOGICAL AND CONSERVATION MISSION OF THE

TEMPLE OF HATSHEPSUT AT DEIR EL-BAHARI

PRELIMINARY REPORT

SEASON 2010-2011

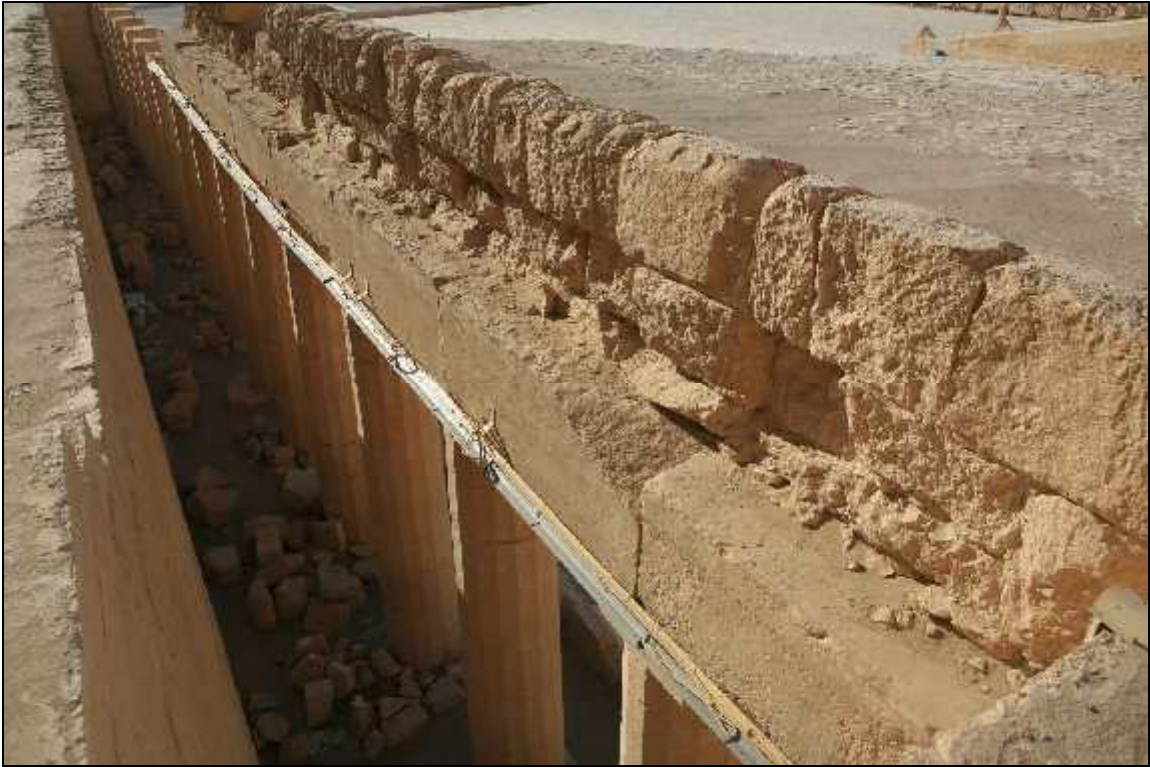
Fig. 4.A

High-tension cables were assembled with screws to ancient (sic!) walls and architraves of the temple. Recent cable trenches connected with floodlighting Deir el-Bahari had destroyed some parts of the stratigraphy (sic!) in the areas of the temples of Mentuhotep II, Tuthmosis III and Hatshepsut.

4.A Architraves of the North Colonnade, Middle Courtyard (photo M. Jawornicki)

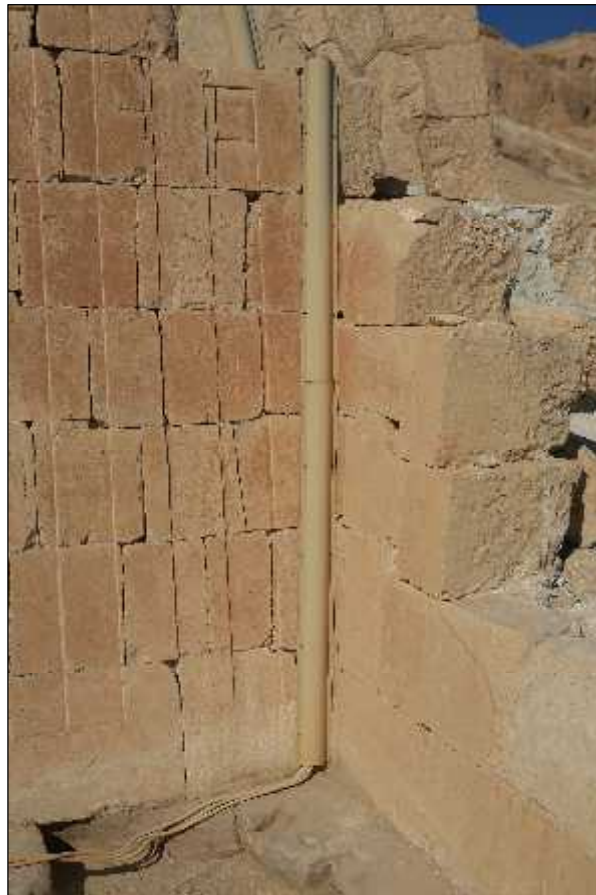
Fig. 4.B

4.B Southern wall of the Portico of the Obelisks, Lower Terrace (photo M. Jawornicki)

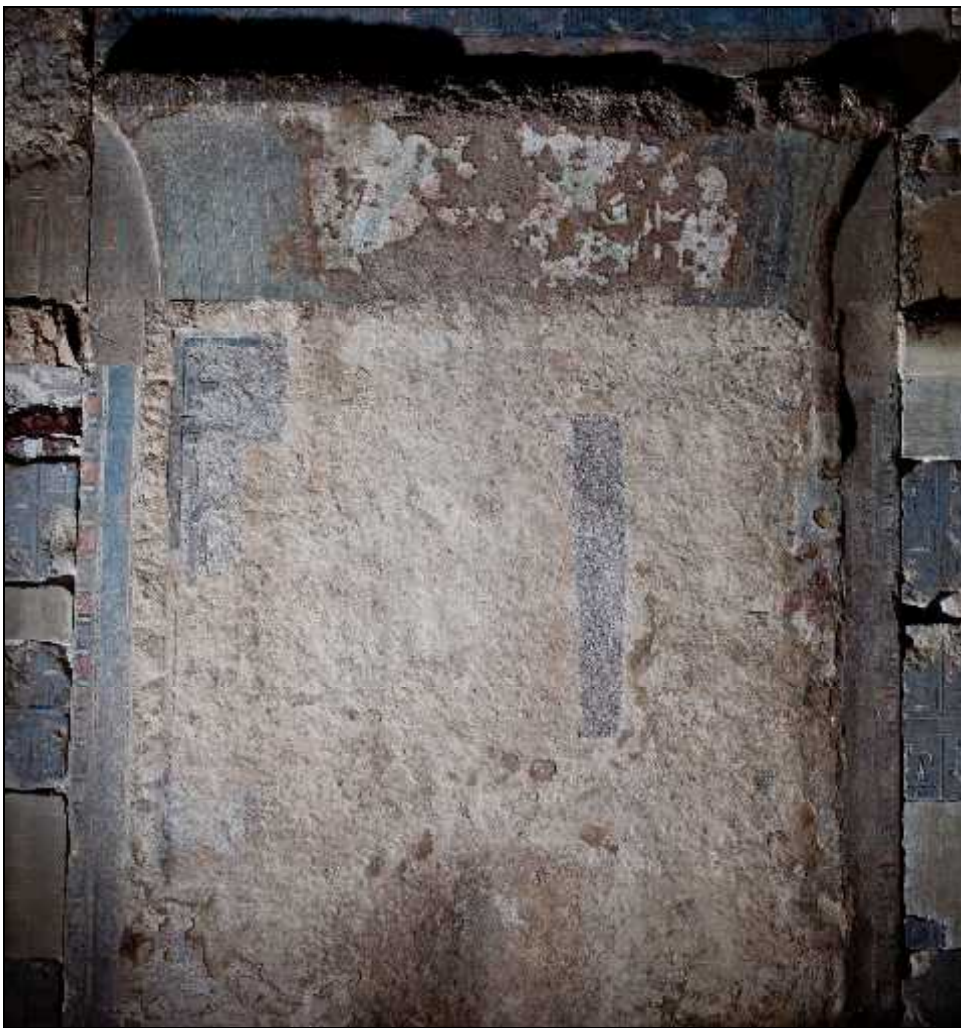
Fig. 6

The false door in the west wall of the Chapel, reused as apse in Coptic time, has been cleaned. In the result of this work, we had expected that some parts of hieroglyphic text would appear. At the same time, we intend to preserve and conserve parts of Coptic original decoration which exists now on the false door. In an undecorated area (84 cm by 14 cm), in the central part of the false door, Coptic gesso-mortar has been removed, Fig. 6. Beneath, it has appeared that the granite door was completely destroyed during Coptic activity. Ergo, hieroglyphic inscriptions, not destroyed, may be expected but at the edges of the granite slab.

6 False door in the Chapel of Hatshepsut: uncovered areas of an hieroglyphic inscription (left) and damaged (in Coptic times) middle part of the door (photo M. Jawornicki)

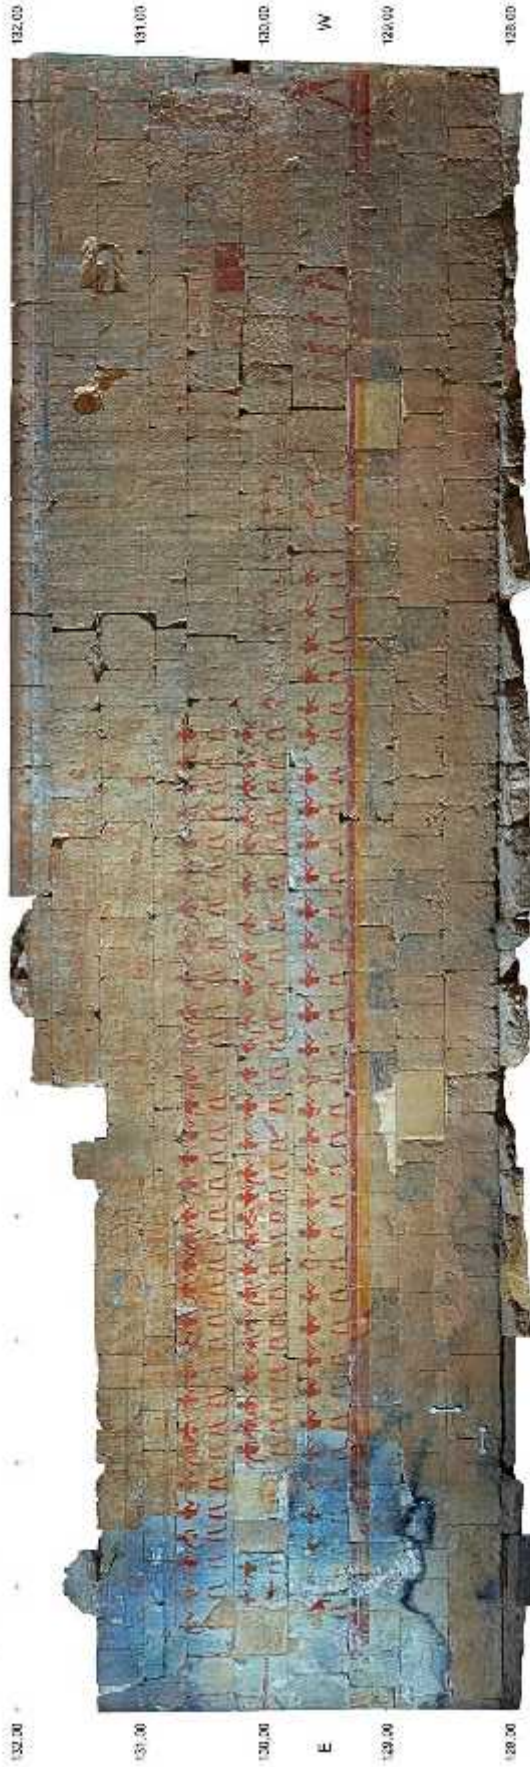
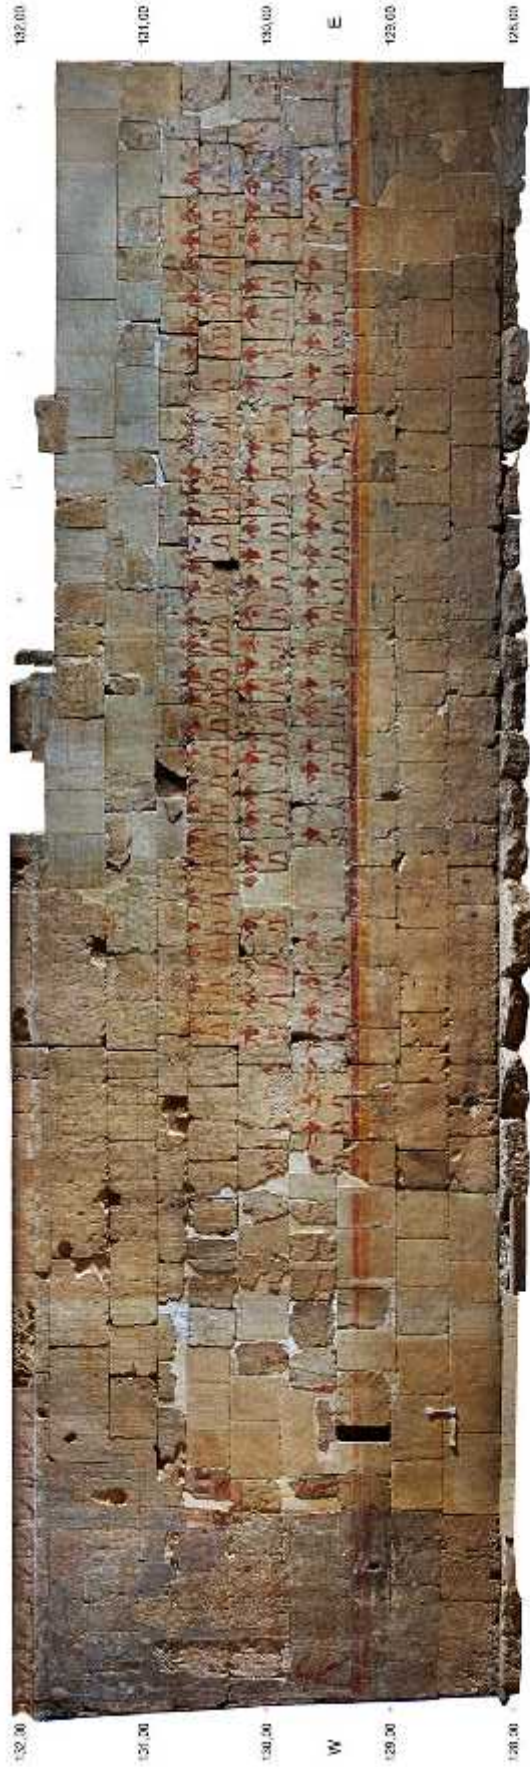
CHAPEL
OF
HATSHEPSUT

Documentation of the Chapel's decoration with application of a Leica-scanner has been elaborated and photo-mosaics, calibrated with 3D cloud, were completed, Fig. 7.

7 Chapel of Hatshepsut, Southern and Northern Walls, photomosaics calibrated with 3D cloud (photos M. Jawornicki, photomosaics J. Kościuk)

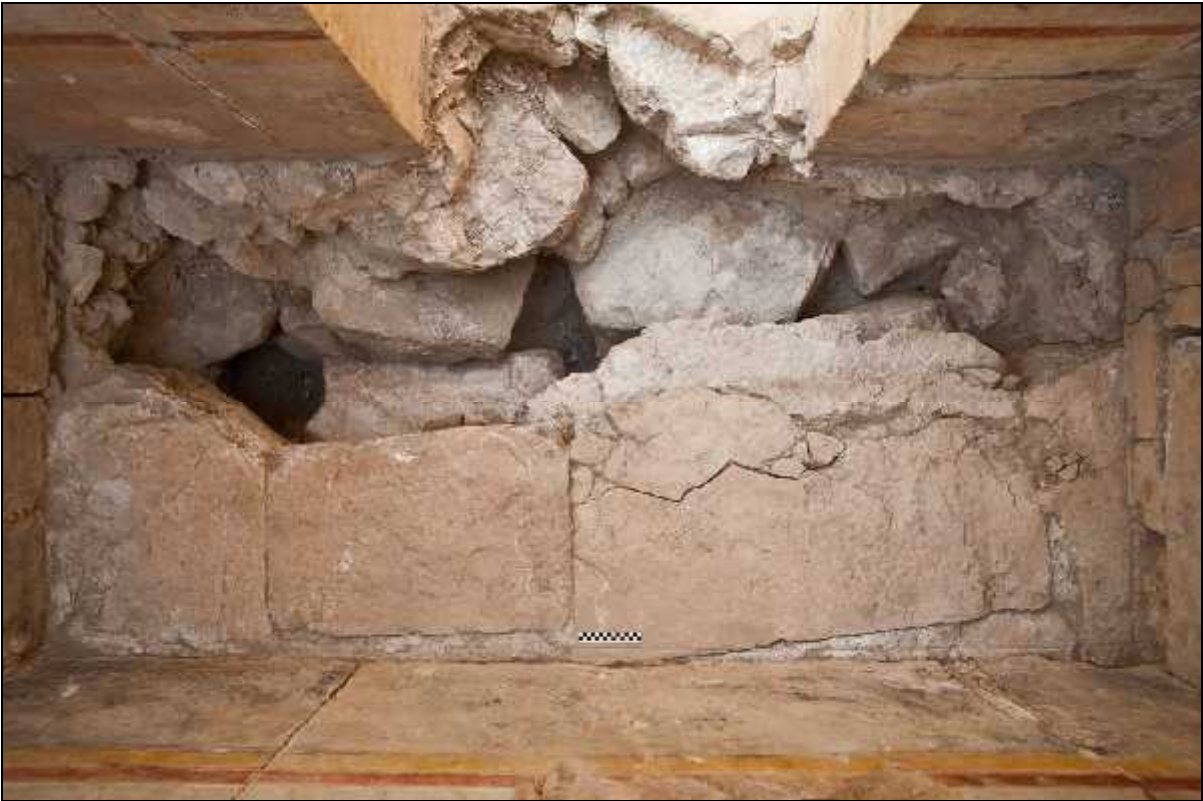
Fig. 8.A

The conservation work in Niche A, located in the Eastern Wall of the Vestibule (CRC-V), has been carried on. The conservation treatment was applied to the ceiling slab of the niche. The floor of the niche has been reinforced and restored with new pavement blocks originated from the temple masonry, Fig. 8A & 8B.

8.A After excavations inside the floor and consolidation of the niche's foundation (photo W. Wojciechowski)

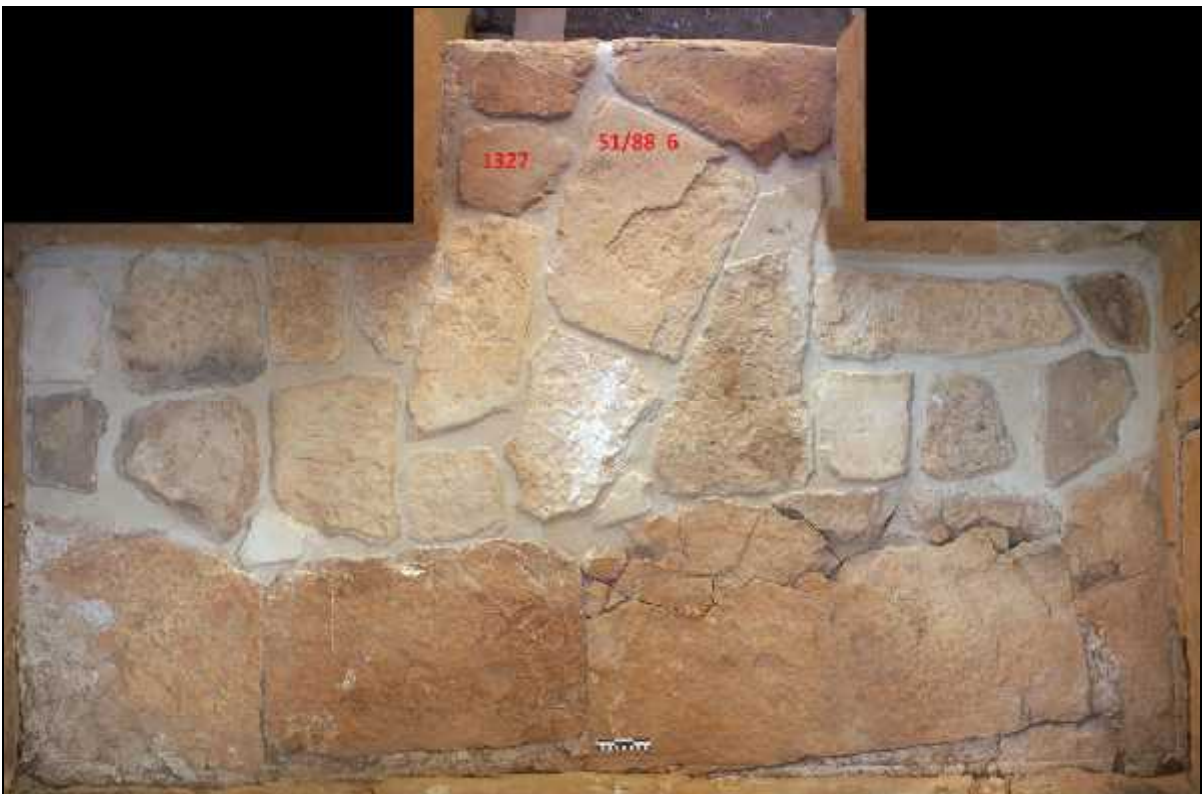
Fig. 8.B

8.B Floor of the niche after restoration (photo M. Caban)

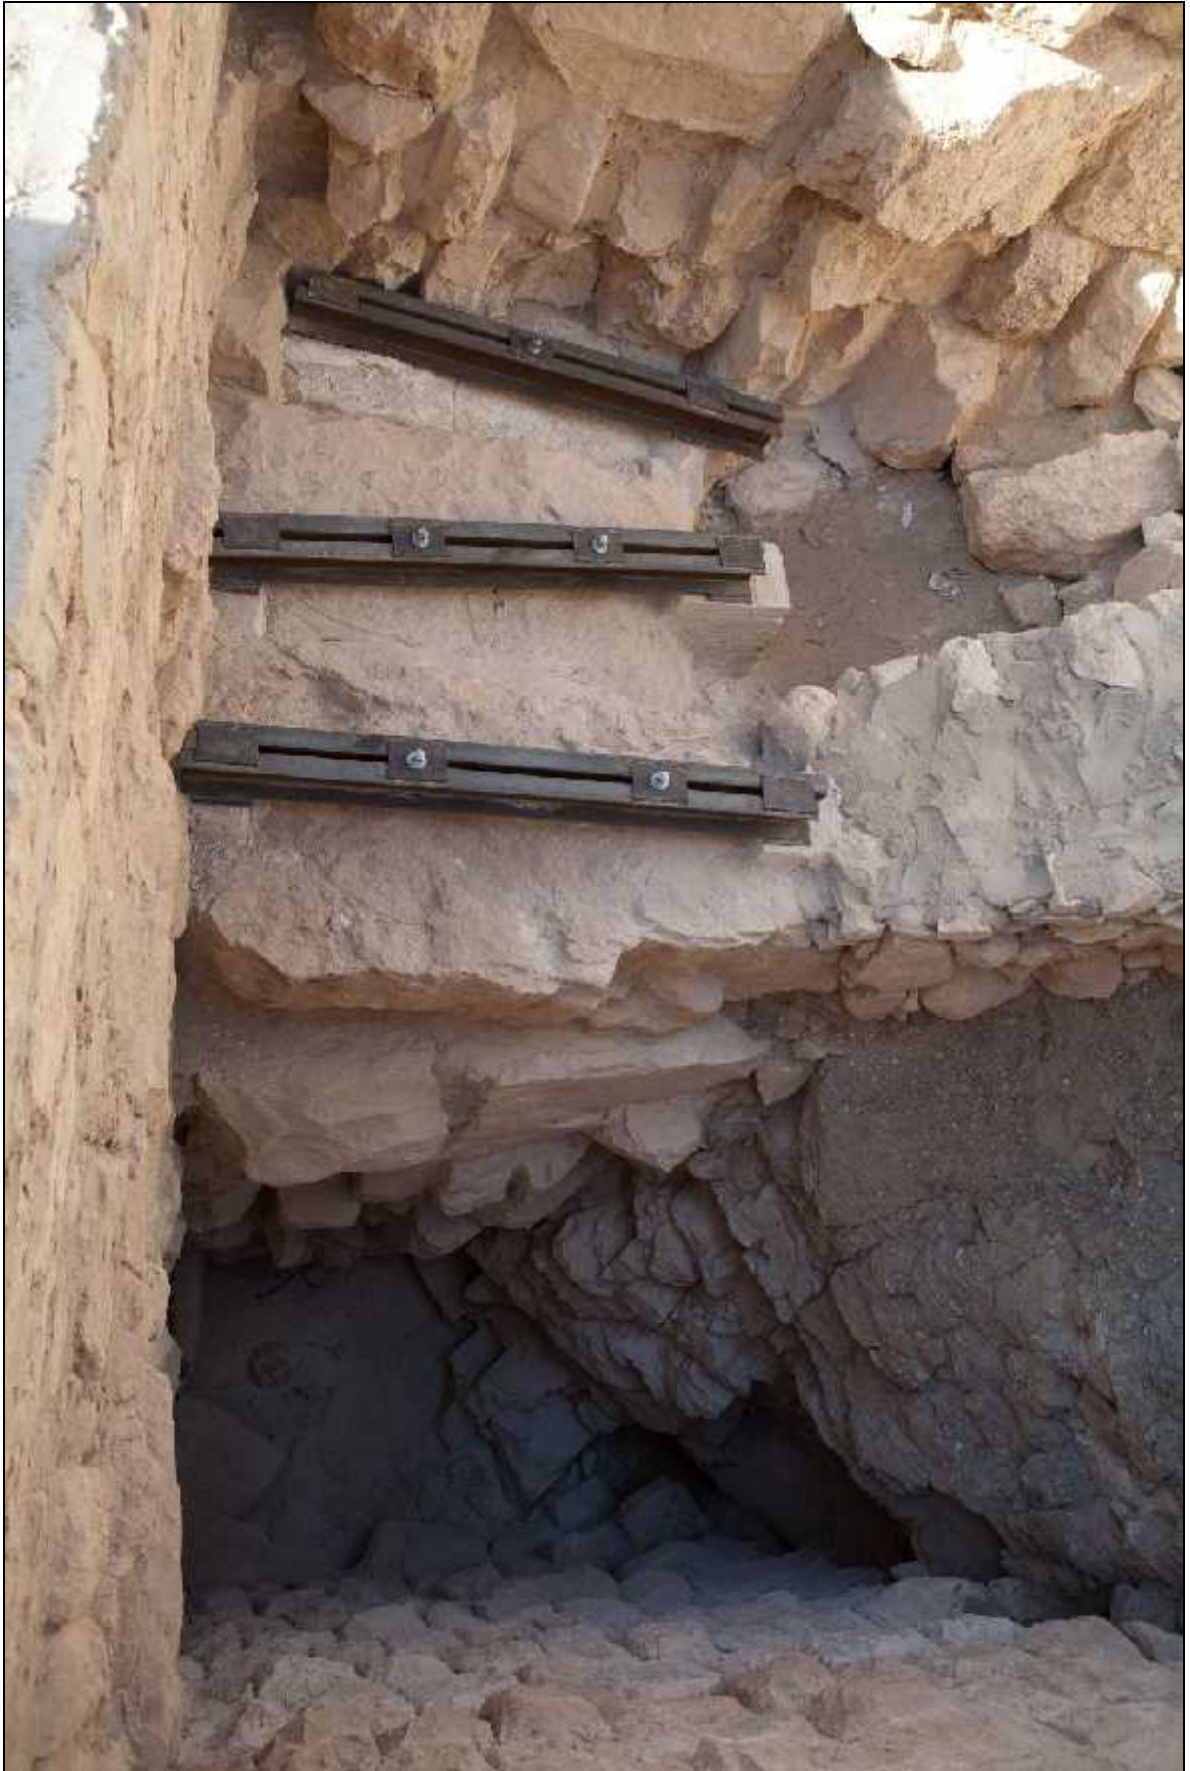
Fig. 9

The presented sketch (above, by M. Michiewicz) shows, from north to south, cracks in two big slabs (each: c. 160 x 81 x 60 cm) and in two smaller slabs (c. 92 x 61 x 50 cm; c. 70 x 40 x 50 cm) of Niche D (the northern niche) in the Vestibule of the Hathor Shrine. Most dangerous and main cracks are marked in red (lower part of the slabs) and in green (upper part of the slabs).

9 Hathor Shrine – Vestibule, Niche D: three steel beams (2? 140) positioned above the limestone roof slabs of the niche (photo M. Jawornicki)

The sketch (to left, by M. Michiewicz) illustrates the idea of protection and reinforcement of the slabs above Niche D of the Vestibule of the Hathor Shrine.

The three slabs were drilled, less than 35 cm deep, in order to install steel arbors. In five holes (diameter 22 mm), resin HILTI was injected. Five steel arbors (bowstrings), with thread (M2M) in their upper edge, were installed inside the holes. After 24 hours, the arbors were twisted to three steel beams (2? 140) positioned above the limestone roof slabs, Fig. 9.

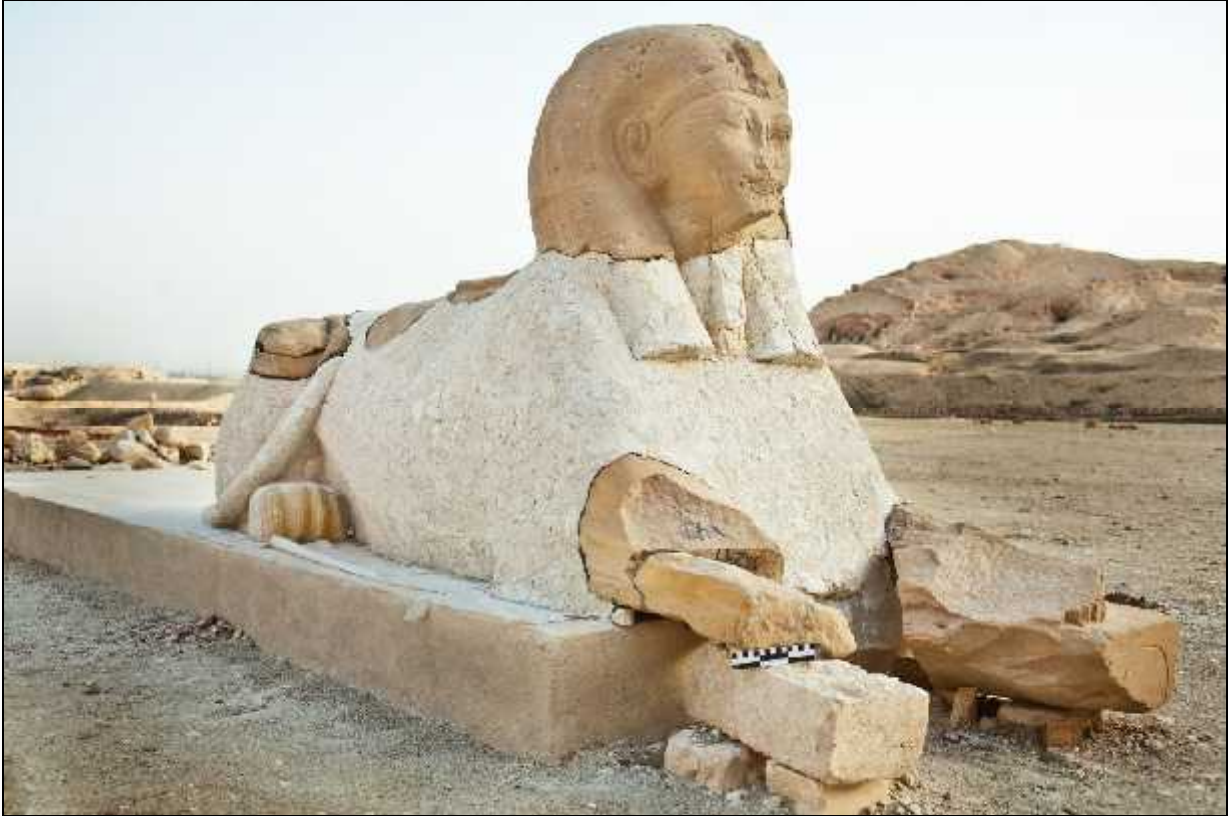
Fig. 10

We have started restoration of two sandstone sphinxes of Hatshepsut discovered in pieces by the Metropolitan Museum of Art Expedition in the 20s of the last century. During season 2010-2011, we plan to restore one, Fig. 10, (or two?) of the sandstone sphinxes of Hatshepsut discovered in pieces by the Metropolitan Museum of Art Expedition in the 20s of the last century².

10 Preliminary reconstruction of an Hatshepsut sandstone sphinx (photo W. Wojciechowski)

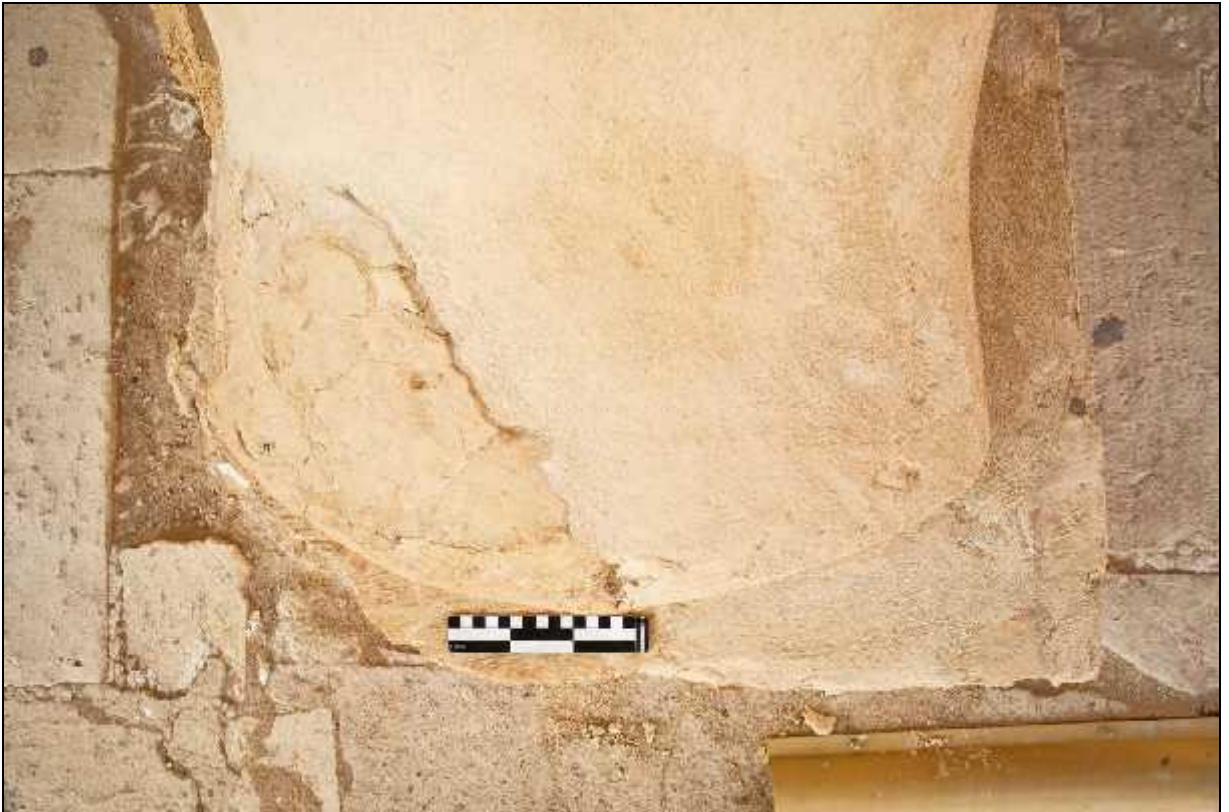
Fig. 11

From Osiride IV, a fragment of the statue basis, that with a round corner³, was mounted into the basis of Osiride XIII – located at the entrance (north) to the Upper Portico, Fig. 11. A fragment of the basis of Osiride XIII was moved and mounted into Osiride XVI – a new statue of the Queen in the form of Osiris, to be restored.

11 Fragment of the statue basis with a round corner was mounted into the basis of Osiride XIII – located at the entrance (north) to the Upper Portico (photo W. Wojciechowski)

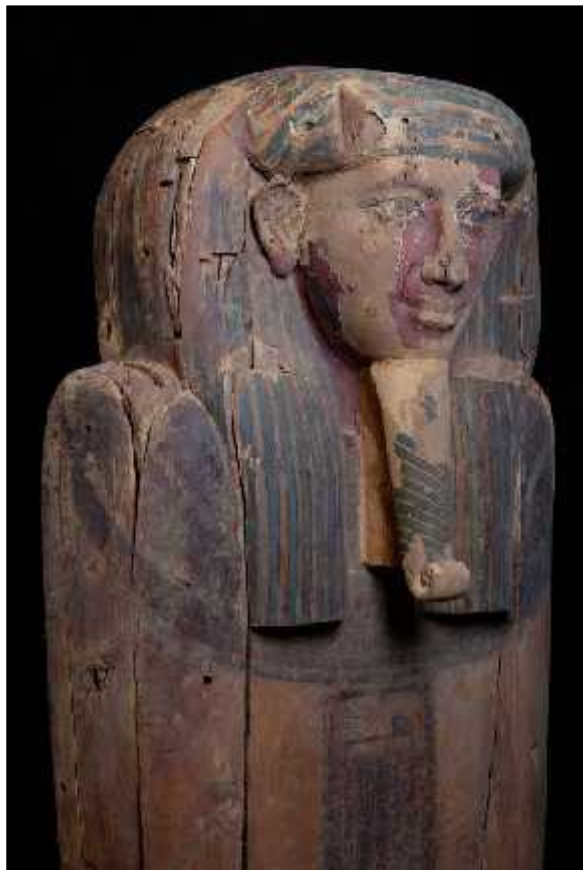
Fig. 12.A

The extant objects from the Baraize find at Deir el-Bahari⁵ are stored in museums and magazines, among them, there are those in the basement of the Luxor Museum. Photographic documentation of two outer coffins, found in the temple of Hatshepsut and stored in the Luxor Museum, namely those of Vizier Nespaqashuty (ii) – J.844 and Vizier Padiamonet (ii) – J.845, has been carried on during this season, Figs 12.A & 12.B.

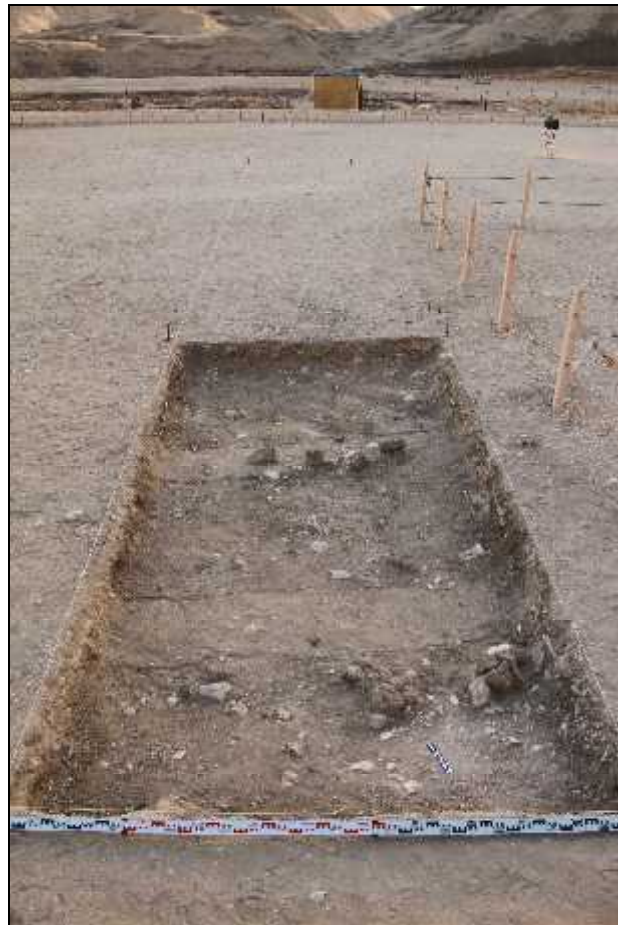
Fig. 14.B

Besides, in Sondage S.2/11 Trenches 1, 2 & 7, the 2011 excavations revealed the trenches of former excavators searching for internal structures. They were spaced about a metre apart and were comparatively narrow (0.5m) and vertical sided, though within the excavation it was low material, Fig. 14.B. There were a number of modern finds from these trench fills which may allow them to be dated: it is suspected that they come from an early phase of the investigation of the temple, perhaps by Eduard Naville⁶.

14 Lower Terrace, trial trenches to the eastern edge of the T-shaped pools with garden:
14.A Trench S.1/11 (photo D.F. Wiczorek)
14.B Trench S.2/11 – excavations revealed two trenches of former excavators (photo D.F. Wiczorek)

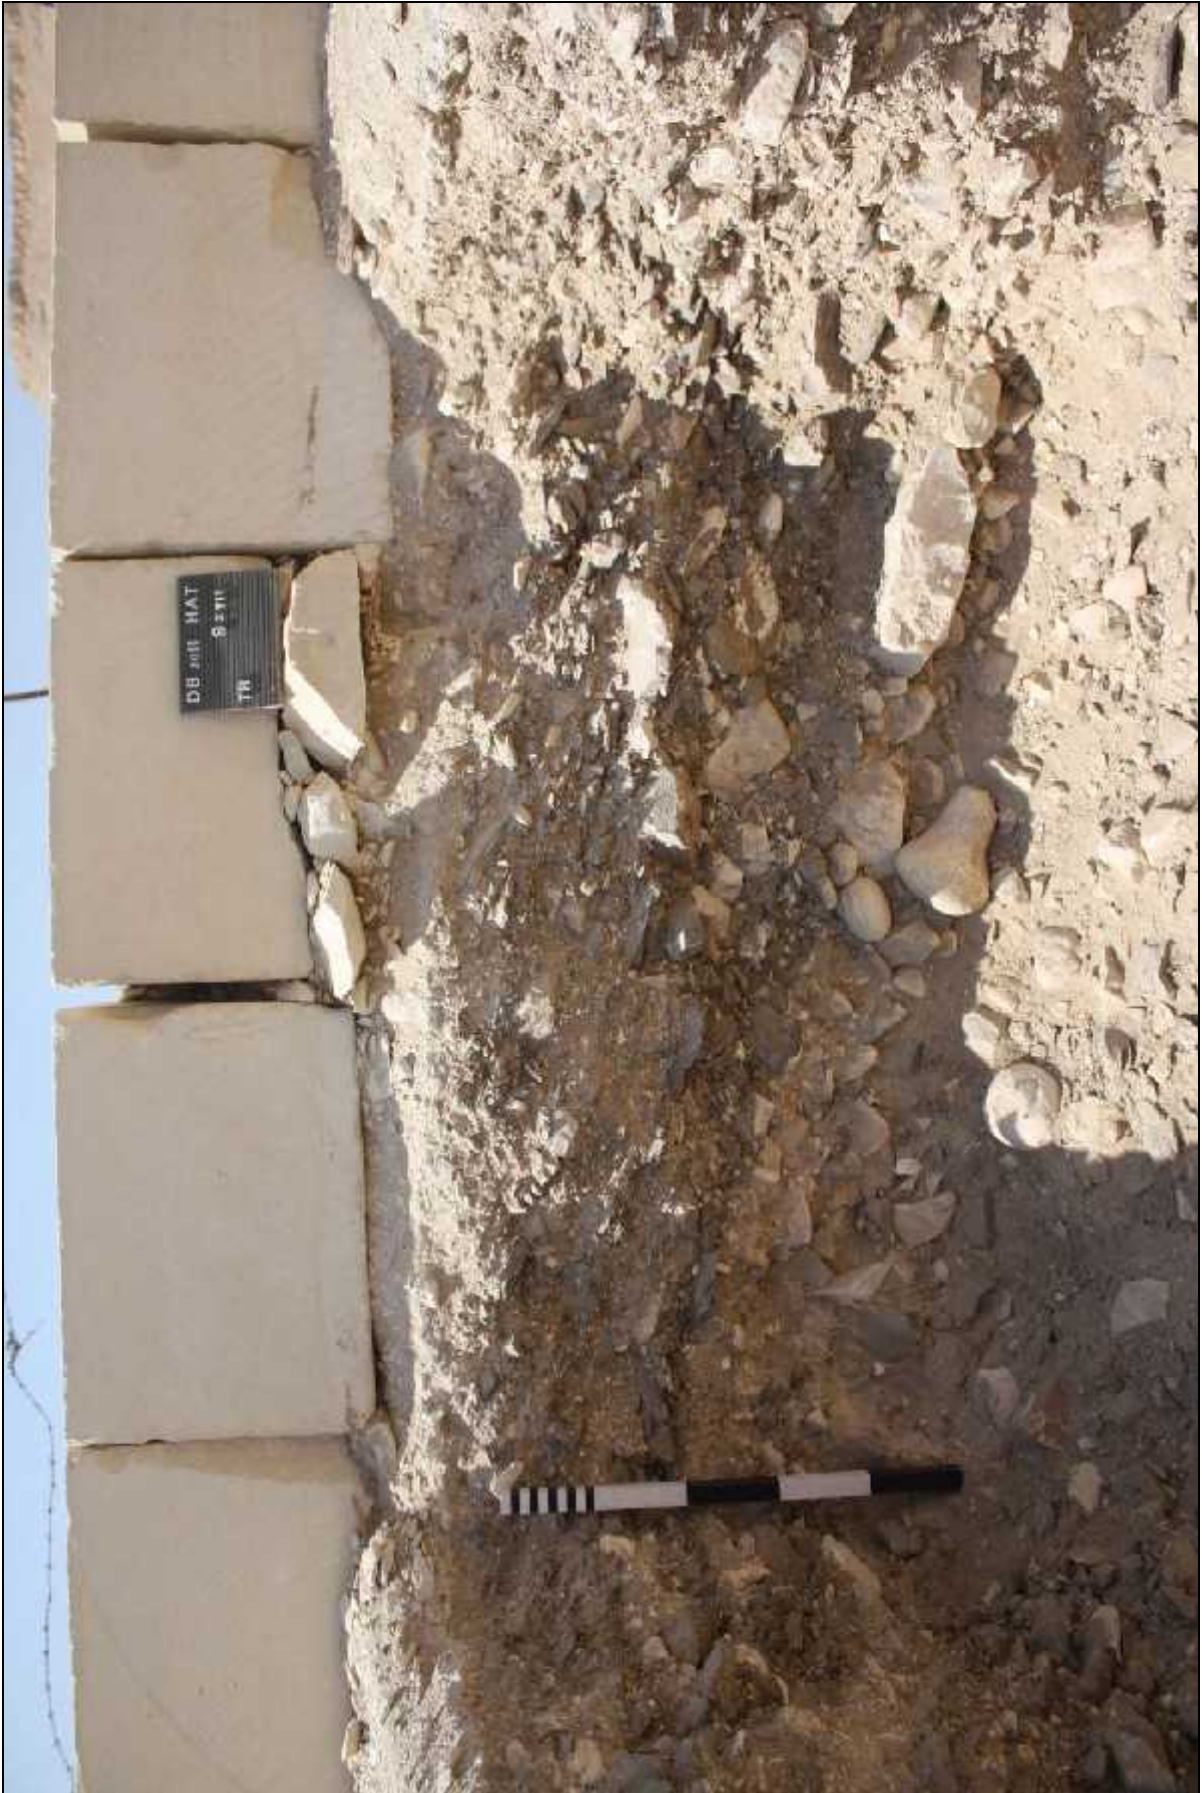
Fig. 15

Excavations at the modern restored southern enclosure wall of the Lower Courtyard (S.2/11 Trench 7) revealed any foundation or any trace of an ancient wall, Fig 17. It seems that there are no

15 Lower Terrace, excavation along the northern edge of the modern restored southern enclosure wall - S.2/11 Trench 7 – the excavation revealed any traces of ancient wall (photo Z.E. Szafrński)

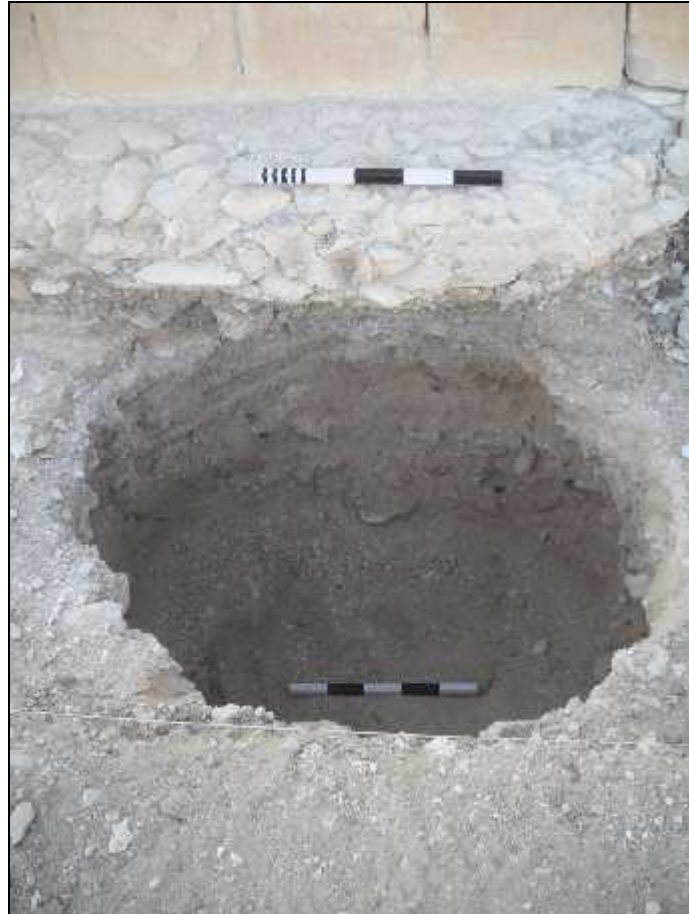
Fig. 16.A

It seems clear that a tunnel was dug under the northern limb of the Gate, visible in the west profile of Trench 1, Fig. 16.A. No such deposit is documented in the archives, neither is there any documentation of this trench. The tunnel was dug for a Third Intermediate Period tomb, once discovered perhaps in a search for a foundation deposit under the limb; it seems possible that it was dug by Winlock. The tomb was robbed and refilled with the remains of its grave goods. This is well testified in the east profile of Trench 3, Fig. 16.B.

16 Lower Terrace, excavation by the foundation of the Hathor Ramp Gate – S.3./11. A Third Intermediate Period tomb was dug under the northern limb of the Gate, disturbed and robbed in a search for a foundation deposit, at the beginning of and in the 20th century. The area was crossed by recent cable trenches connected with floodlighting the Temple which had destroyed some parts of the stratigraphy.

16.A Tunnel visible in the west profile of Trench 1. Note the steeply-dipping geological deposits visible in the side of the feature (photo P. M. Barford)

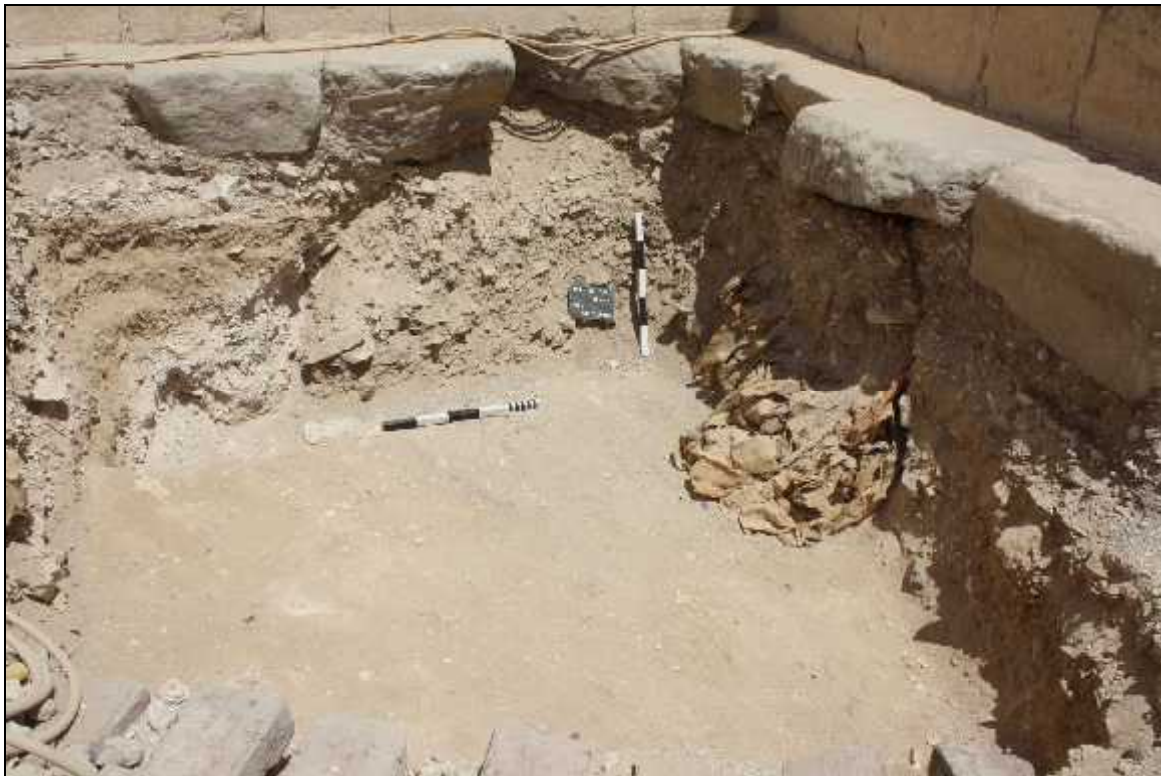
Fig. 16.B

16.B Tunnel and remains of grave goods visible in the north and east profiles of Trench 3 (photo Z.E. Szafrński)

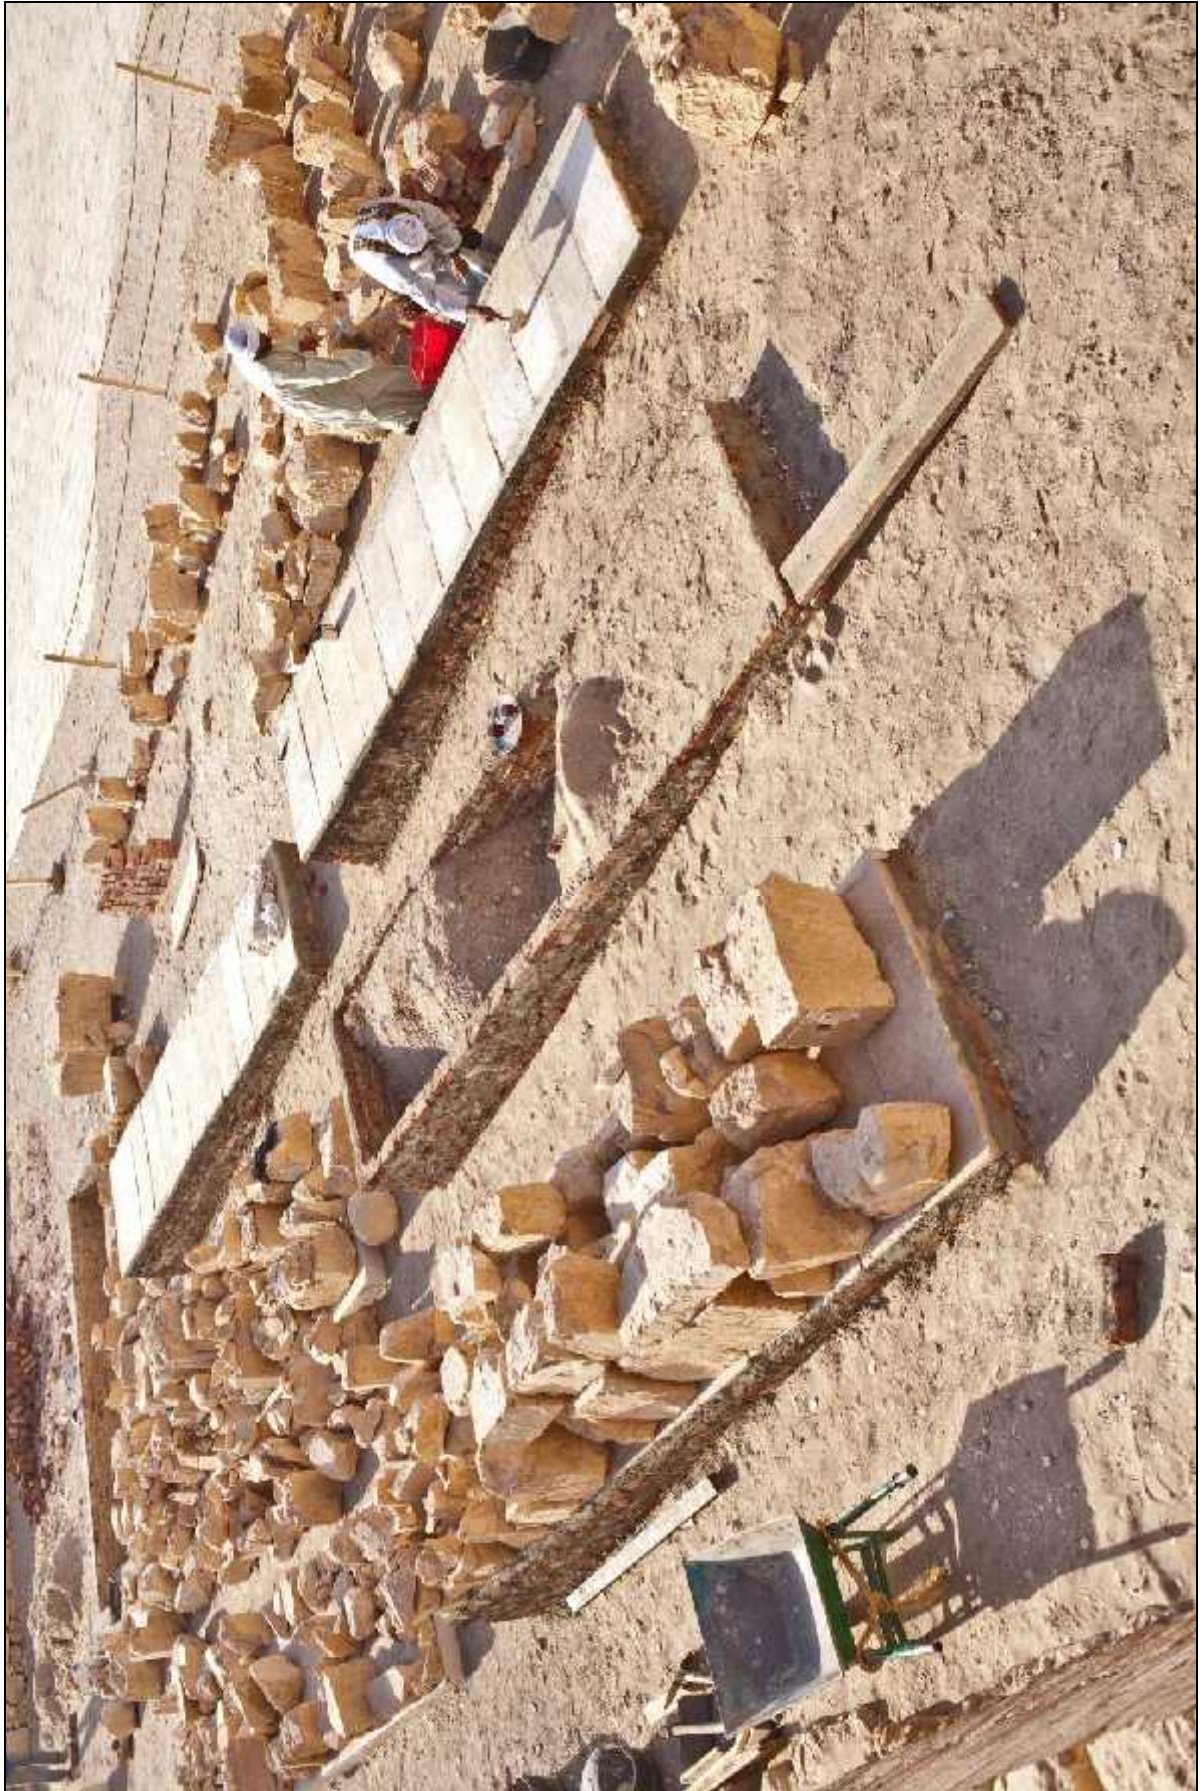
Fig. 17

On the request of Mr. Mustafa Waziri, MA, General Director of West Thebes, six new mastabas has been built in the northern part of the Middle Courtyard, Fig. 17. The work will be continued during next season.

17 Construction of matabas in the Middle Courtyard of the Temple of Hatshepsut (photo W. Wojciechowski)
