**EGYPTIAN-POLISH ARCHAEOLOGICAL AND CONSERVATION MISSION
OF THE**

**TEMPLE OF HATSHEPSUT
AT DEIR EL-BAHARI**

REPORT

SEASON 2011-2012

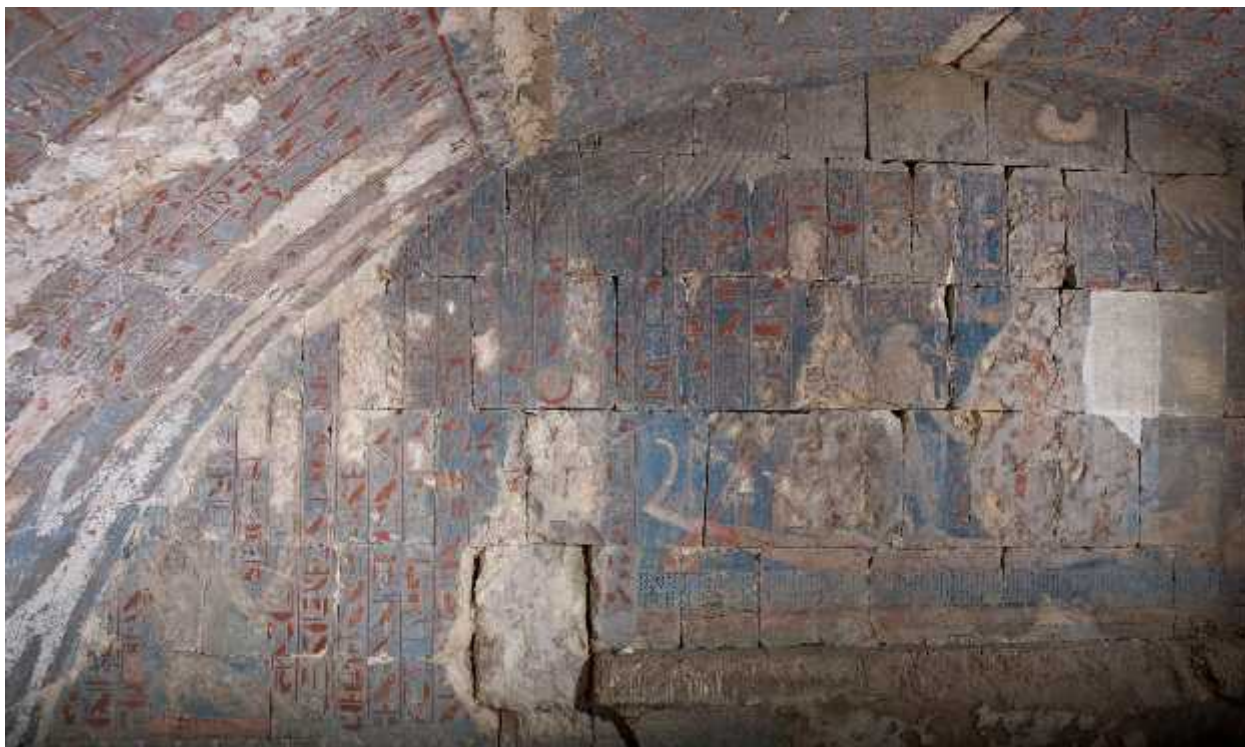
Fig. 1

1. Chapel of Hatshepsut, upper part of the West Wall – scene of sun-bark. After conservation (photo M. Jawornicki)
2. Chapel of Hatshepsut, the joint (corner) of the ceiling and upper part of the West Wall. Ancient reparations are visible after conservation (photo M. Jawornicki)

The western part of the ceiling was cleaned and went under conservation treatment, *Fig. 1*. In the result of this work New Kingdom reparations and some parts of hieroglyphic texts have appeared, *Fig. 2*. At the same time, we intended to preserve and conserve parts of Coptic original decoration which still exists on some places of the ceiling.

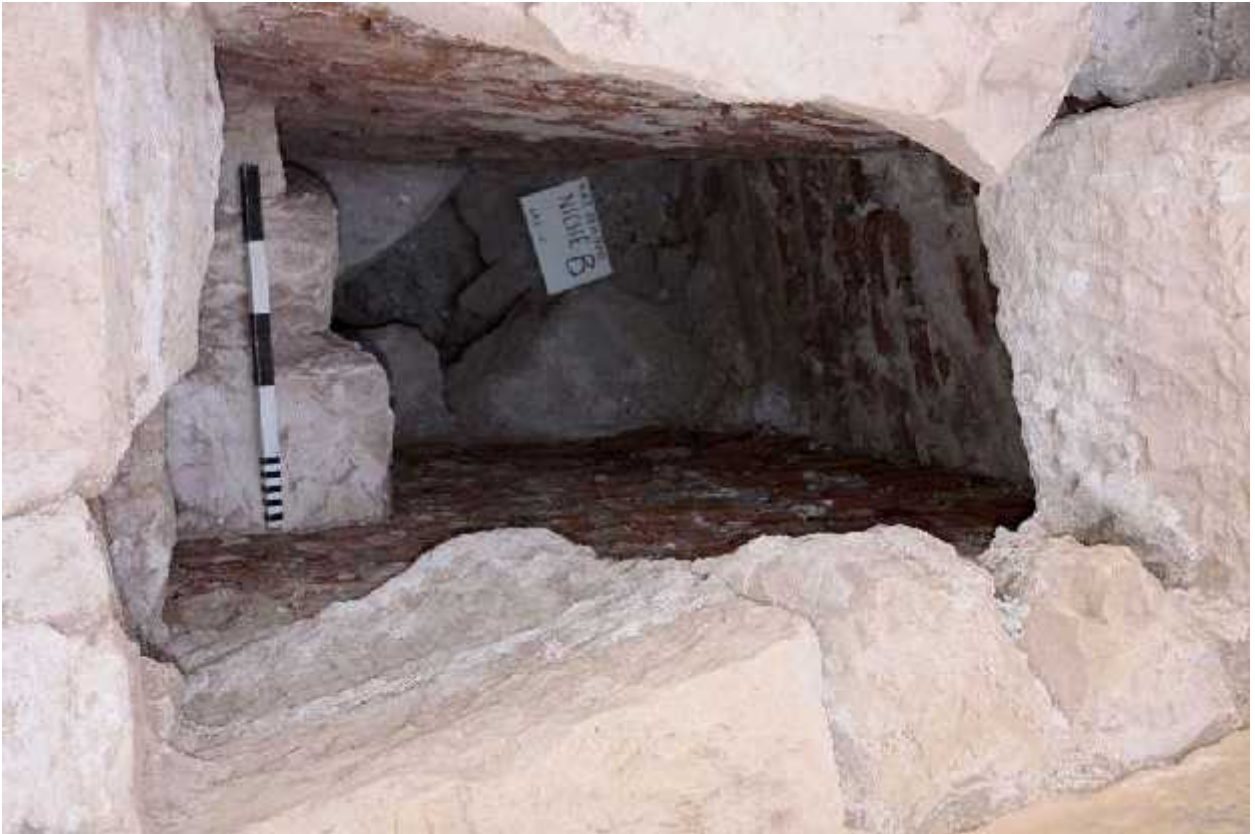
Fig. 3

3. Complex of the Royal Cult – Vestibule. Niche B – consolidation of the foundation with three red-brick walls (photo Z.E. Szafranski)
4. Complex of the Royal Cult – Vestibule. Niche B – preliminary restoration of the pavement (photo Z. E. Szafranski)

The conservation and stabilisation work in **Niches A and B**, located in the **Eastern Wall of the Vestibule**, have be conducted. Under the pavement of Niche B, the foundations of its western, northern and eastern walls have been reinforced with red brick walls, *Fig. 3*, positioned on a solid structure. The space under the pavement was refilled with *gebel*-material and sand; a missing part of the pavement was preliminary reconstructed, *Fig. 4*.

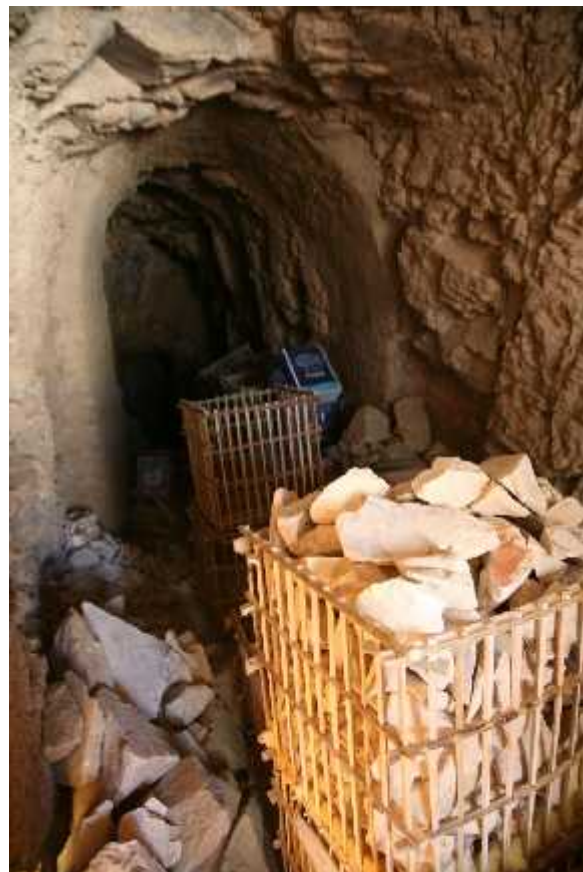
Fig. 21

Magazine-tomb MMA 828 is located behind the Mission's dig-house, it is the so-called „Tomb of the mummies”, *Fig. 21*. In previous season, during the examination of the stored material a fragment of architrave bearing the name of Khenemet-ankh was discovered; this is the name of the temple of Tuthmosis I – known only from written sources.⁴ During this season, the documentation work have been continued. The last registered fragment-block bears number 6501.

- 1) Storage room of the temple of Tuthmosis III at Deir el-Bahari;
- 2) Magazine-tomb MMA 828, located behind the Mission's dig-house ("*Metropolitan House*"), the so-called „tomb of the mummies”, *Fig. 21*;
- 3) Storage room in Tomb VIII (= S.7A/82) inside the Chapel of Hatshepsut, *Fig. 22*.

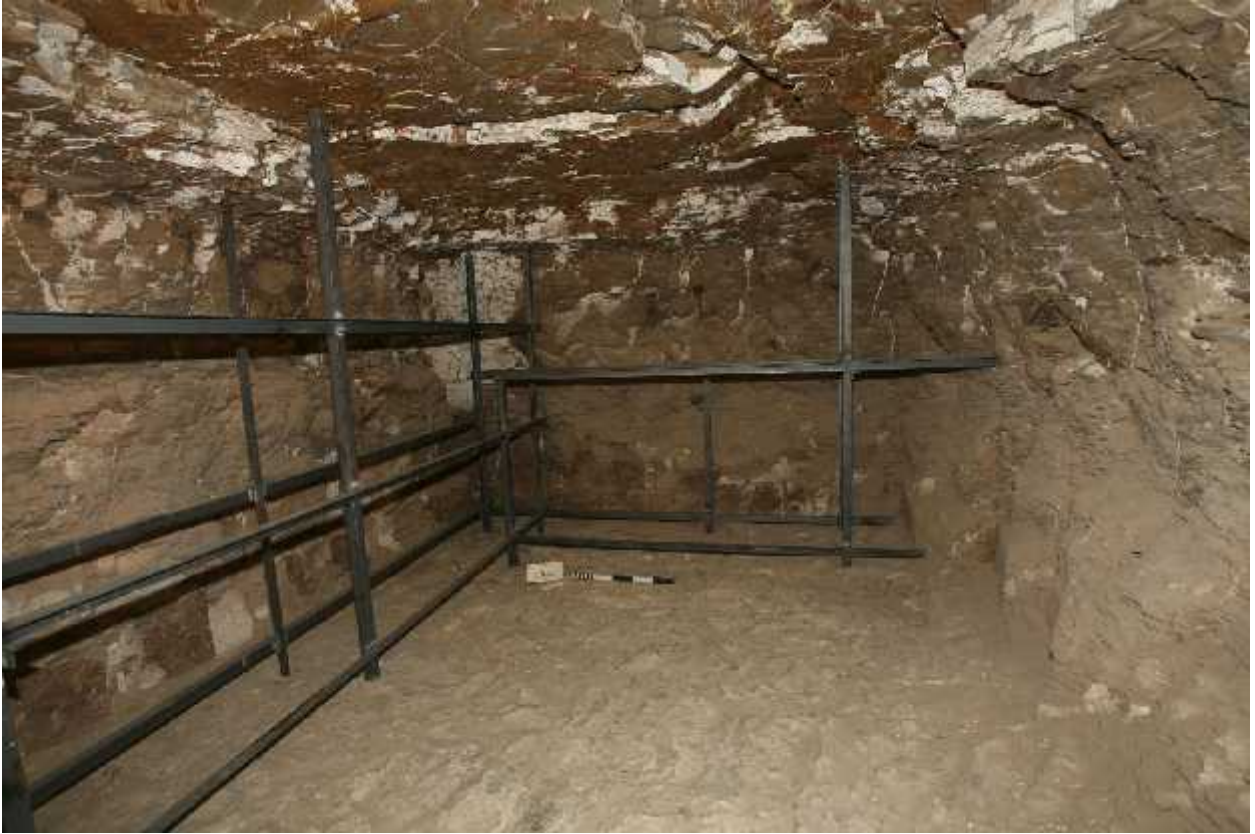
Fig. 22

21. Fragments of blocks of the temple of Tuthmosis I stored the “tomb of the mummies” - MMA 828 (photo Z. E. Szafranski)
22. Chapel of Hatshepsut, burial chamber of Tomb VIII (S.7A/82) prepared to store objects (photo M. Jawornicki)

inside its burial chamber, *Fig. 22*. On the shaft-mouth, a rectangular construction, made of steel wires in mortar, was executed in order to frame then a glass-door of the shaft. In future, a lighting system will show tourists the inside of the tomb.

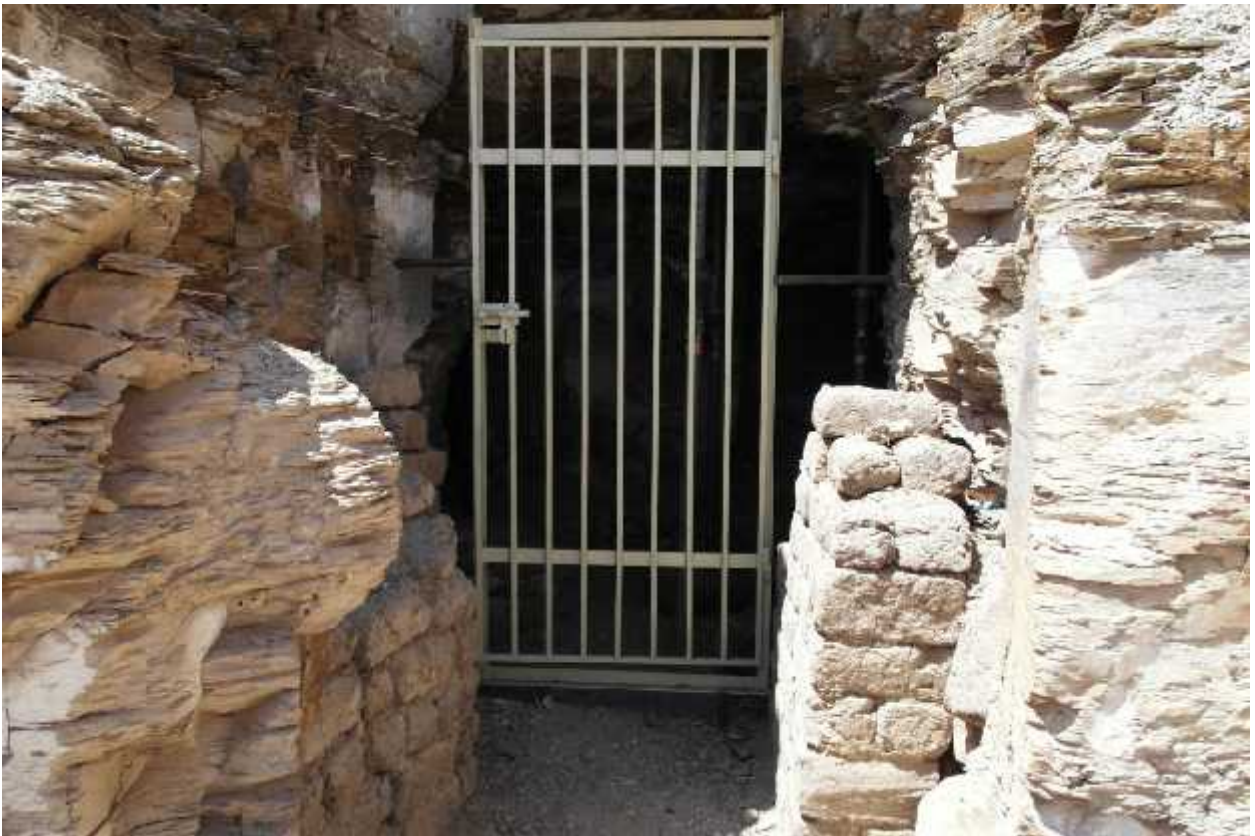
Fig. 23

23. Tomb II protected with a steel gate (photo M. Jawornicki)
24. Gilded wooden figurine of Hapi, son of Horus (inv. no 1708)– one of the remains of robbed grave goods in Tomb II, Dyn. 25/26 (photo M. Jawornicki)

Undecorated tomb of the late Third Intermediate Period – Tomb II, located in the mountain, to the west of the Temple of Tuthmosis III, was robbed in antiquity. The tomb, which will store pottery material found in the temple of Hatshepsut, was protected with a steel gate, *Fig. 23*.

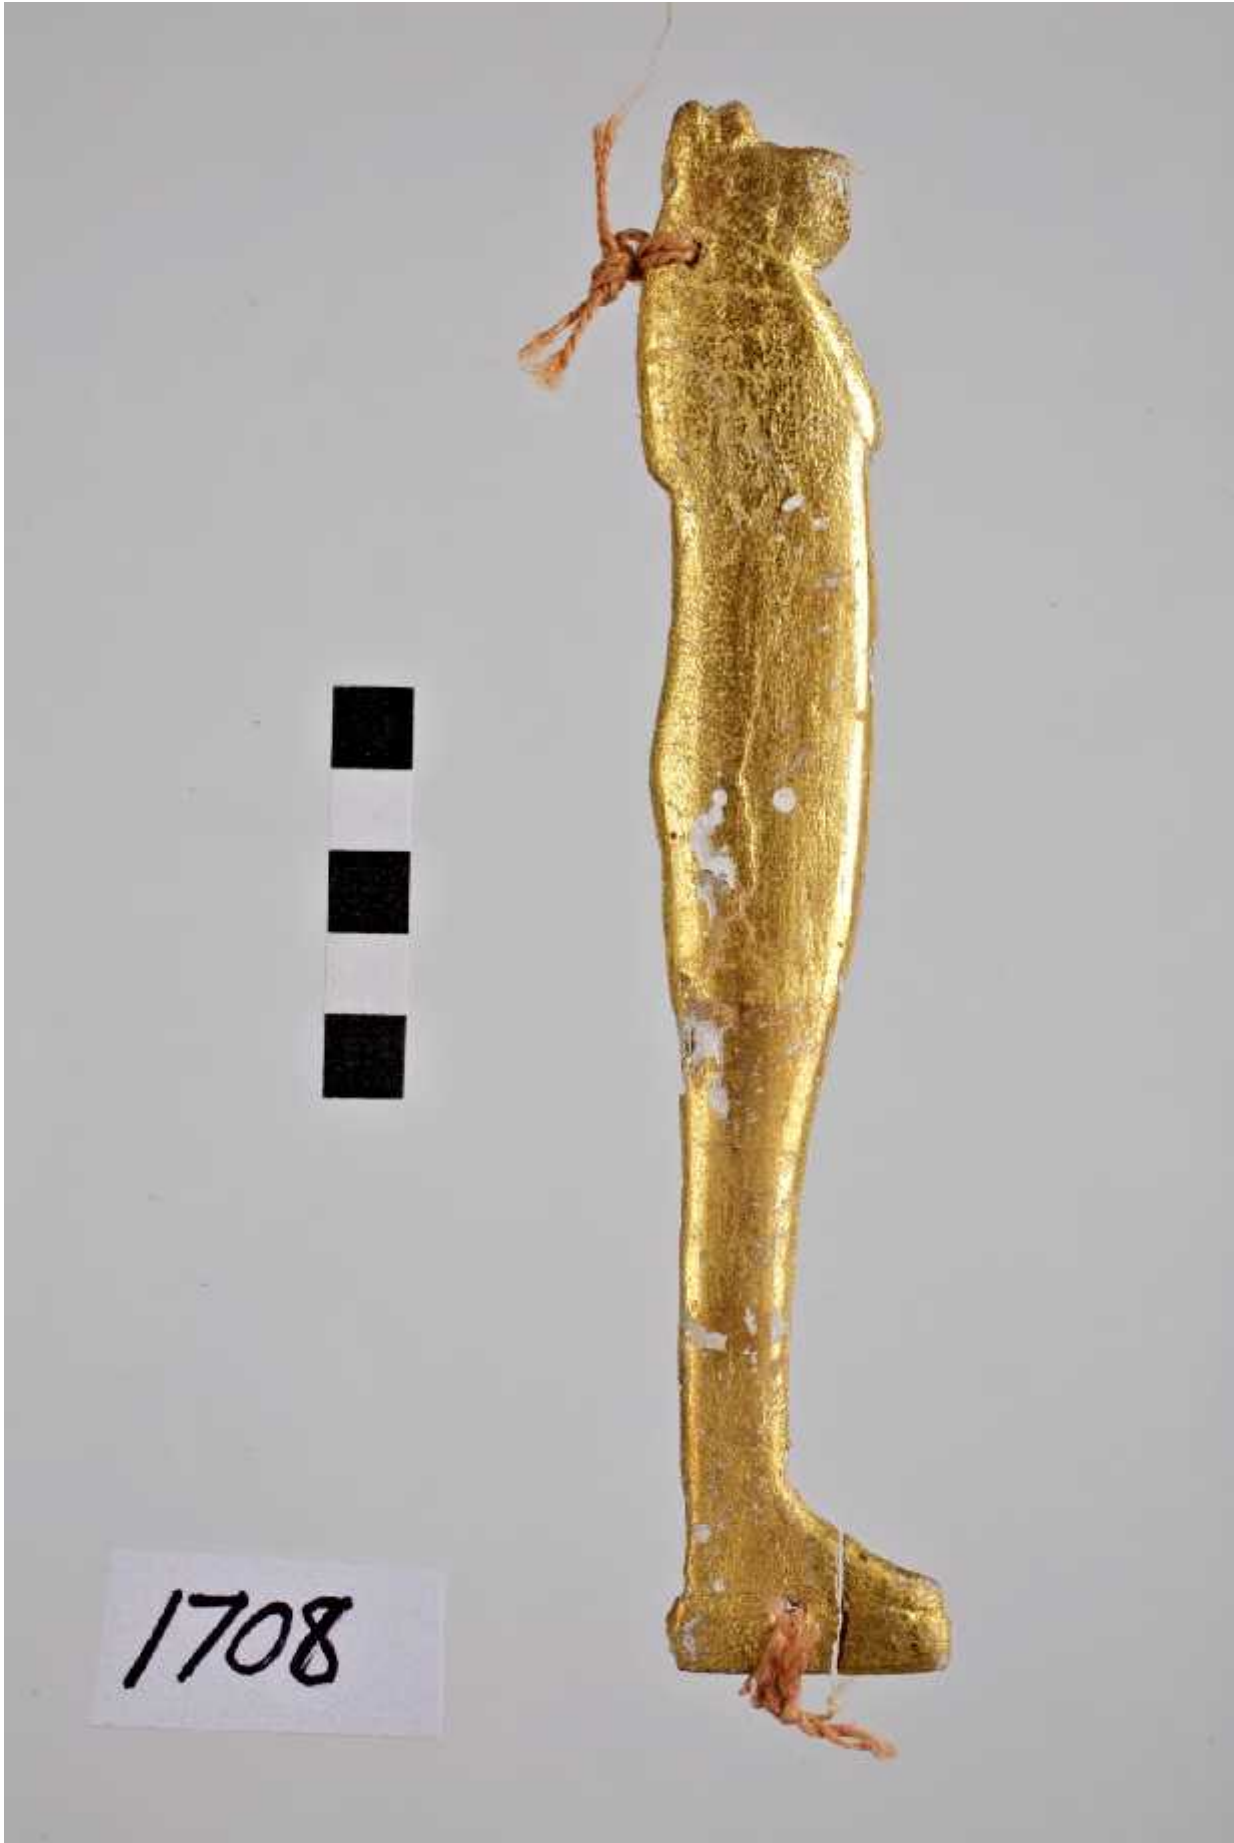
Fig. 24

The remains of archaeological material, found inside one of the tomb's upper chambers (Room A), point to the late 25th – the early 26th Dynasties as to the time of its execution. Among the discovered objects, a figurine of one of the Horus' sons, made of gilded wood, was found, *Fig. 24*.

J There were temple's blocks reused in the so-called „**Tomb II**”, located in the mountain, to the west of the Temple of Tuthmosis III at Deir el-Bahari, *Fig. 23*; the tomb was robbed in Antiquity. We have remove the blocks from the tomb; they will be used in reconstruction works of the temple. The collected archaeological material, *Fig. 24*, indicates that the tomb was constructed in the 25th/26th Dynasty.

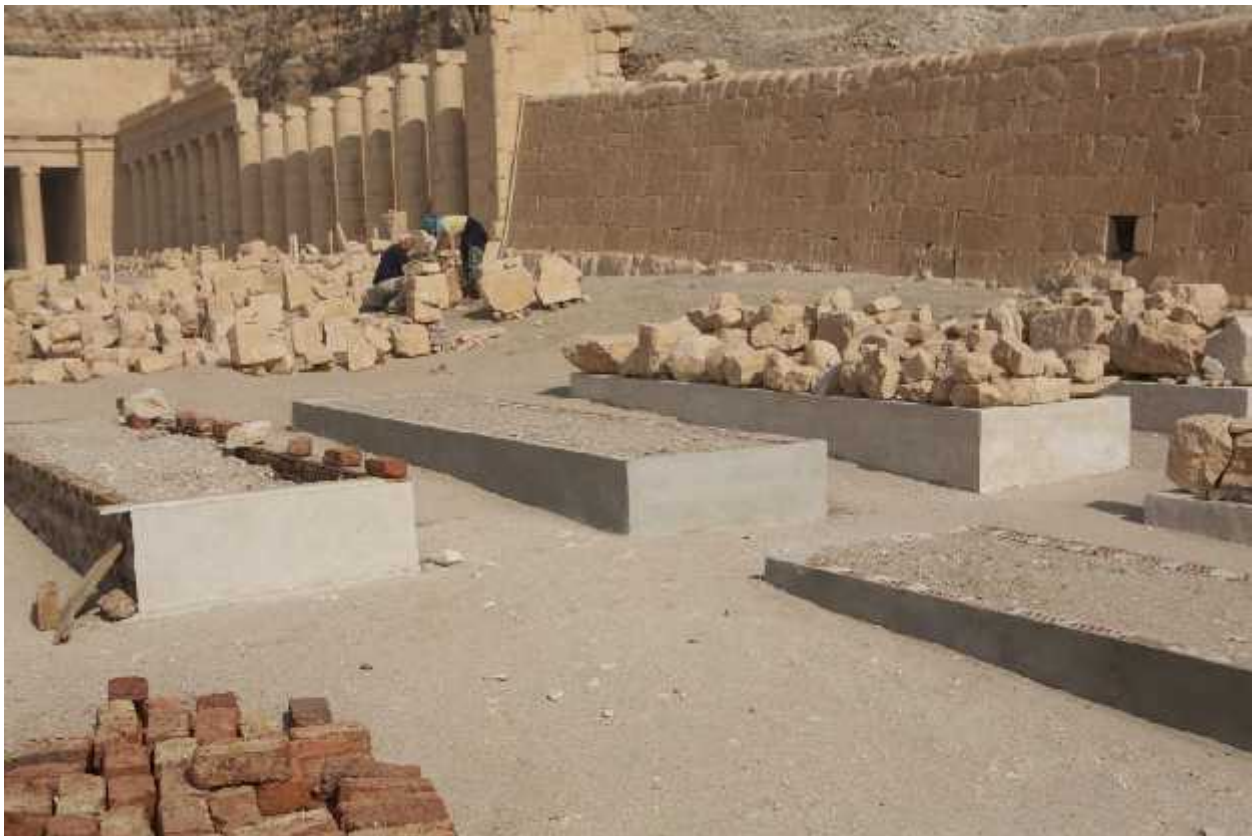
Fig. 31

L. The Mission has **constructed banks** (*mastabas*) in aim to collect sets of block fragments representing temple decoration. The idea is to create a “Hatshepsut Temple Block-yard Open-air Museum”, *Fig. 31*.
